# Access Compliance Report Public Rights-of-Way (Curb Ramps)

| Main Street: DANA_DR | | Cross Street: DANA_DR | | Location: | S |
| ADA ID: RPRK220221162807 | Ramp Type: Type 4 - Parallel | Initial Pass/Fail: Pass | Overall Compliance: No | Severity Score: | 5 |

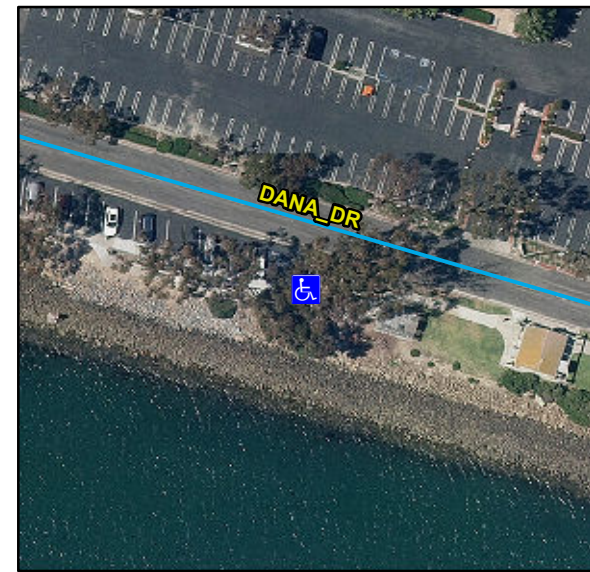
| Compliance | Description | Data | Compliance | Description | Data |
|---|---|---|---|---|---|
| Yes | Landing Run Slope (%) | 0.8 | No | DWS Full Width | No |

Possible Solutions:

**Remove & Replace Detectable Warning System.**

**R305.1.4, STD 1115**
