# Access Compliance Report

## Public Rights-of-Way

### (Curb Ramps)

Main Street: ISLAND\_WAY Cross Street: ISLAND\_WAY Location: E

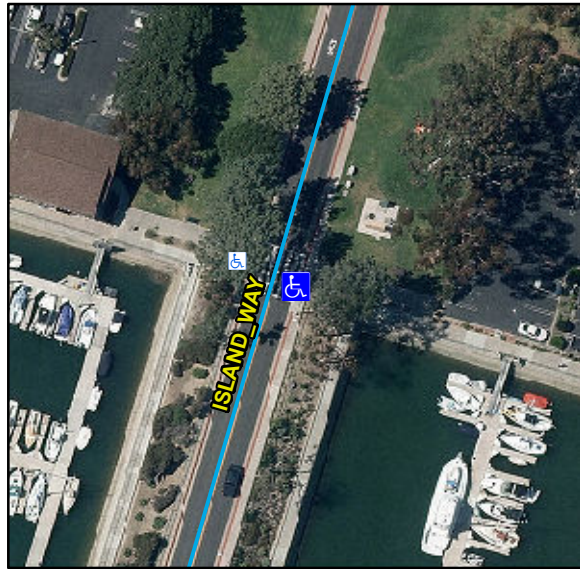
ADA ID: RPRK220221171844 Ramp Type: Type 4 - Parallel Initial Pass/Fail: Pass Overall Compliance: Yes Severity Score: 0

N/A
