# Access Compliance Report Public Rights-of-Way (Curb Ramps)

Main Street: DANA\_POINT\_HARBOR\_DR Cross Street: N/A Location: S

ADA ID: RPRK220221180858 Ramp Type: Type 4 - Parallel Initial Pass/Fail: Pass Overall Compliance: No Severity Score: 5

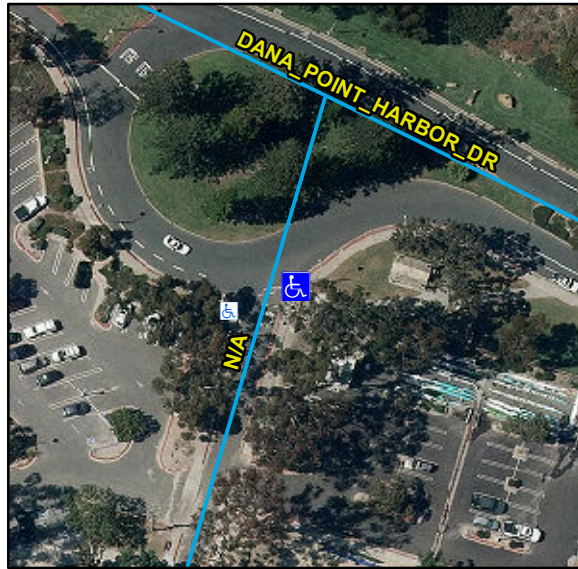
| Compliance | Description | Data | Compliance | Description | Data |
|---|---|---|---|---|---|
| No | Gutter Run Slope (%) | 9.6 | | Road Cross Slope (%) | N/A |

Remove & Replace Gutter.

R304.5.4, STD 1115
