# Access Compliance Report Public Rights-of-Way (Curb Ramps)

Main Street: N/A Cross Street: HARBOR\_BLV Location: S

ADA ID: RPRK220222165718 Ramp Type: Type 7 - Directional 2 Initial Pass/Fail: Pass Overall Compliance: No Severity Score: 12

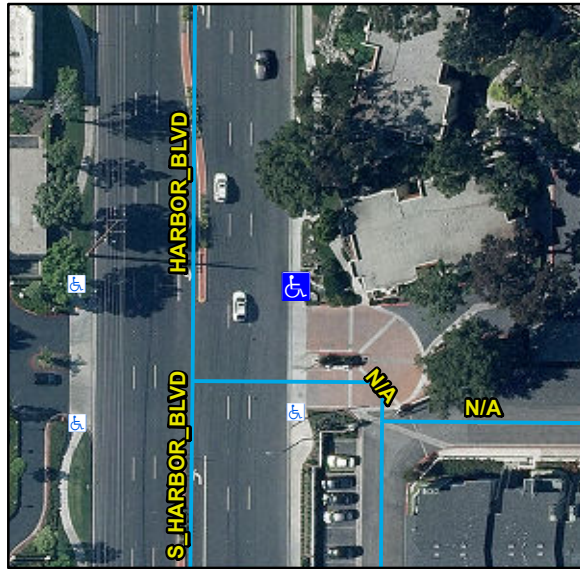
| Compliance | Description | Data | Compliance | Description | Data |
|---|---|---|---|---|---|
| No | Grade Break Cross Slope (%) | 5.2 | N/A | Flare Slope RT (%) | N/A |
| Yes | Landing Width (in) | 53 | No | DWS Full Width | No |
| No | Landing Cross Slope (%) | 4.4 | Yes | DWS Left Offset (in) | 0 |
| No | Gutter Run Slope (%) | 9.9 | | Road Cross Slope (%) | N/A |
| No | Gutter Cross Slope (%) | 6.5 | | Parallel Ramp Side | Right |

Remove & Replace Entire Ramp. Remove & Replace Gutter.

R304.5.3, R305.1.4, R305.2, R304.5.4, STD 1115
