# Access Compliance Report Public Rights-of-Way (Curb Ramps)

Main Street: E\_CASSELLE\_AVE Cross Street: PROSPECT\_ST Location: SE

ADA ID: RPRK220222195740 Ramp Type: Type 4 - Parallel Initial Pass/Fail: Pass Overall Compliance: No Severity Score: 0

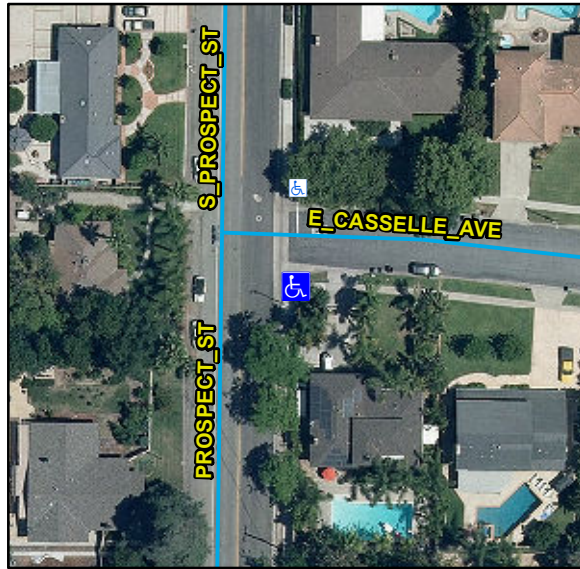
| Compliance | Description | Data | Compliance | Description | Data |
|---|---|---|---|---|---|
| No | Gutter Cross Slope (%) | 3 | Yes | Perpendicular Joint Present | Yes |

Possible Solutions:

Remove & Replace Gutter.

R304.5.3, STD 1115

Total Cost: \$ 252
