# Access Compliance Report Public Rights-of-Way (Curb Ramps)

Main Street: S\_WOODLAND\_ST Cross Street: KIRKWOOD\_AVE Location: SW

ADA ID: RPRK220222203902 Ramp Type: Type 4 - Parallel Initial Pass/Fail: Fail Overall Compliance: No Severity Score: 2

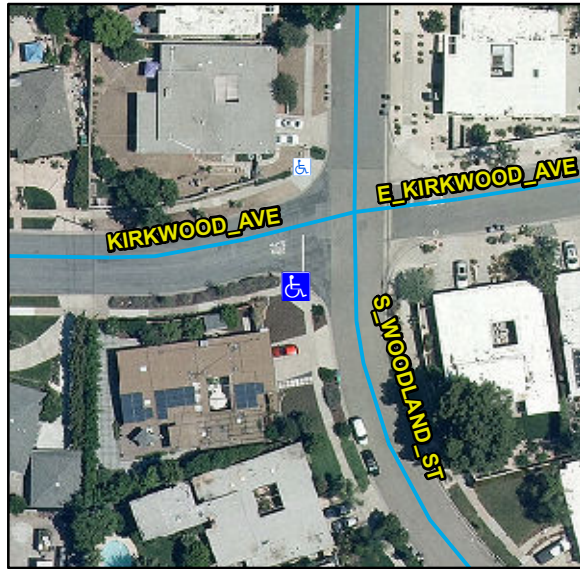
| Compliance | Description | Data | Compliance | Description | Data |
|---|---|---|---|---|---|
| No | Ramp Cross Slope LT (%) | 4.7 | No | Ramp Cross Slope RT (%) | 4.2 |

Remove & Replace Curb Ramp With Two New Directional Ramps or Equivalent.

R304.5.3, STD 1115
