# Access Compliance Report Public Rights-of-Way (Curb Ramps)

Main Street: KIRKWOOD\_AVE Cross Street: S\_WOODLAND\_ST Location: NE

ADA ID: RPRK220222204256 Ramp Type: Type 4 - Parallel Initial Pass/Fail: Fail Overall Compliance: No Severity Score: 15

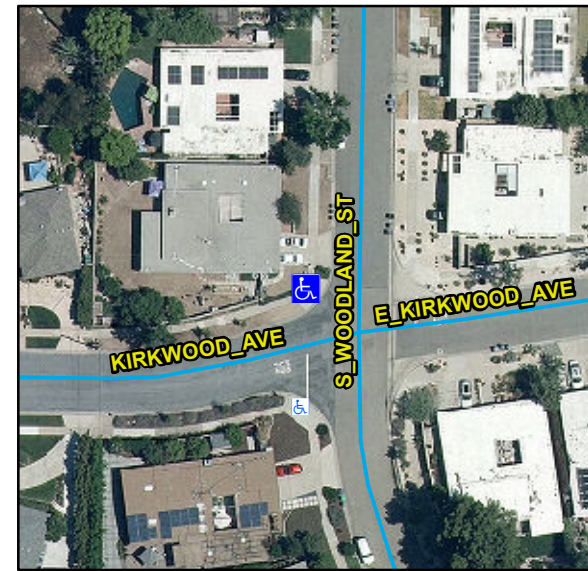
| Compliance | Description | Data | Compliance | Description | Data |
|---|---|---|---|---|---|
| No | Ramp Cross Slope LT (%) | 6.4 | No | Ramp Cross Slope RT (%) | 5.9 |

Remove & Replace Curb Ramp With Two New Directional Ramps or Equivalent.

R304.5.3, STD 1115
