# Access Compliance Report Public Rights-of-Way (Curb Ramps)

Main Street: WOODBRIAR Cross Street: UNIVERSITY\_AVE Location: NW

ADA ID: RPRK220223152150 Ramp Type: Type 4 - Parallel Initial Pass/Fail: Pass Overall Compliance: No Severity Score: 25

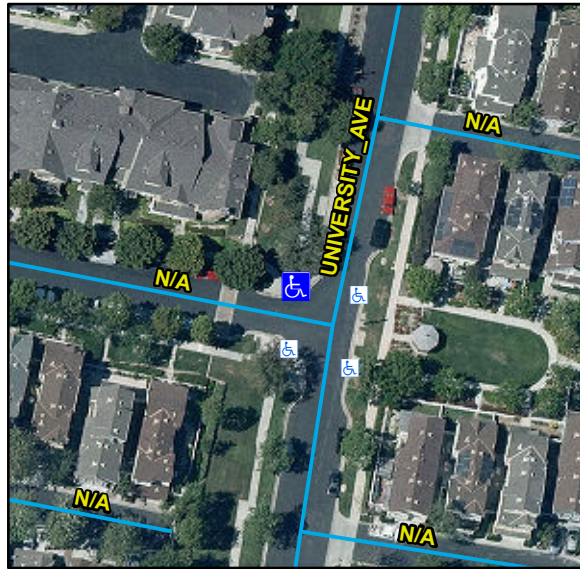
| Compliance | Description | Data | Compliance | Description | Data |
|---|---|---|---|---|---|
| N/A | Landing Present | No | No | DWS Provided | No |
| No | Landing Width (in) | N/A | N/A | DWS Length (in) | N/A |
| No | Landing Run Slope (%) | N/A | N/A | DWS Full Width | N/A |
| No | Landing Cross Slope (%) | N/A | | DWS Offset Type | N/A |
| No | Gutter Run Slope (%) | 6.6 | | Road Cross Slope (%) | 0.8 |

Remove & Replace Curb Ramp With Two New Directional Ramps or Equivalent. Remove & Replace Gutter.
