# Access Compliance Report Public Rights-of-Way (Curb Ramps)

| Main Street: UNIVERSITY_AVE | | Cross Street: WOODBRIAR | | Location: | SE |
| ADA ID: RPRK220223152657 | Ramp Type:Type 1 - Perpendicular | Initial Pass/Fail: Pass | Overall Compliance: No | Severity Score: | 15 |

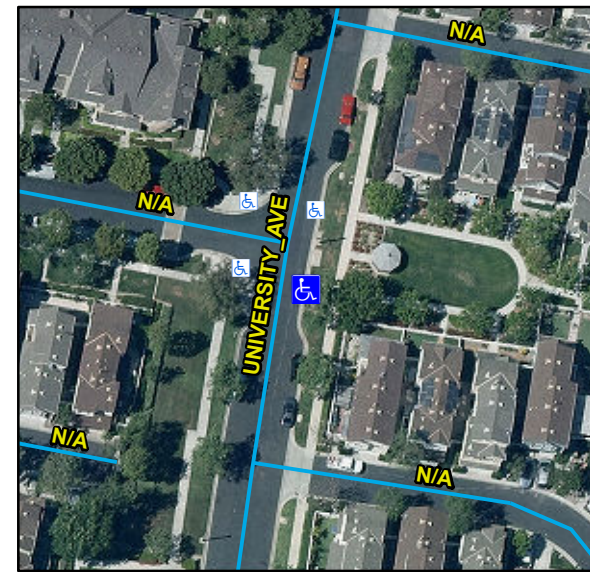
| Compliance | Description | Data | Compliance | Description | Data |
|---|---|---|---|---|---|
| No | Landing Run Slope (%) | 2.1 | N/A | Flare Traversable RT | No |
| Yes | Landing Cross Slope (%) | 2.1 | No | DWS Provided | No |
| No | Gutter Run Slope (%) | 11.6 | | Road Cross Slope (%) | N/A |

Remove & Replace Entire Ramp. Remove & Replace Gutter.

R304.2.2-Perp, R304.3.2-Para, R305, R304.5.4, STD 1115

Total Cost: \$ 3332
