# Access Compliance Report Public Rights-of-Way (Curb Ramps)

Main Street: UNIVERSITY\_AVE Cross Street: FARMHOUSE Location: SW

ADA ID: RPRK220223162641 Ramp Type: Type 4 - Parallel Initial Pass/Fail: Pass Overall Compliance: No Severity Score: 25

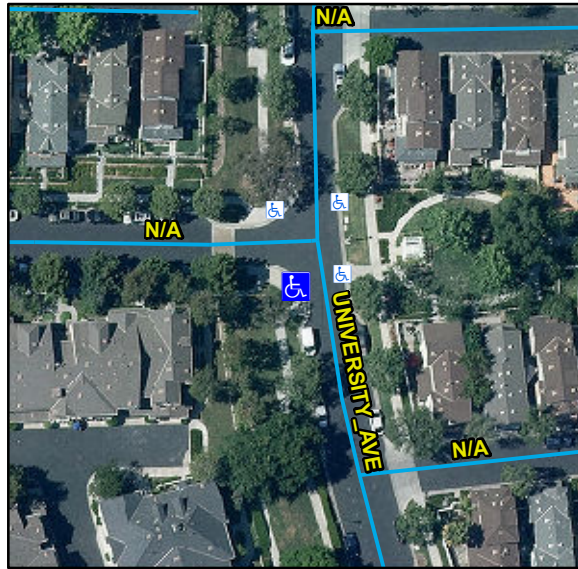
| Compliance | Description | Data | Compliance | Description | Data |
|---|---|---|---|---|---|
| N/A | Landing Present | No | No | DWS Provided | No |
| No | Landing Width (in) | N/A | N/A | DWS Length (in) | N/A |
| No | Landing Run Slope (%) | N/A | N/A | DWS Full Width | N/A |
| No | Landing Cross Slope (%) | N/A | | DWS Offset Type | N/A |
| No | Gutter Run Slope (%) | 9.1 | | Road Cross Slope (%) | 1.4 |

Remove & Replace Curb Ramp With Two New Directional Ramps or Equivalent. Remove & Replace Gutter.
