# Access Compliance Report Public Rights-of-Way (Pedestrian Signals)

Main Street: YORBA\_LINDA\_BLV Cross Street: KILT\_AVE Location: SE

ADA ID: SGAT210917142821 Signal Type: One Push Button-Non APS Overall Compliance: No Severity Scores: BTN 1: 25 BTN 2: N/A No BTN: N/A

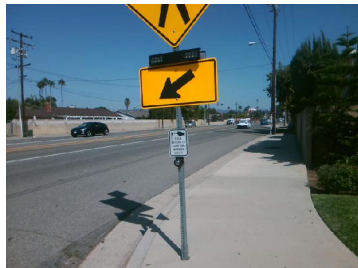
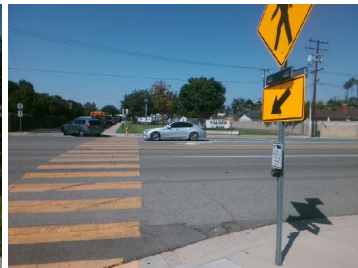
| Compliance | Description | Data | Compliance | Description | Data |
|---|---|---|---|---|---|
| No | B 1 Clear Floor Space Slope (%) | 3.8 | N/A | B 2 Clear Floor Space Slope (%) | N/A |
| No | B 1 DistanceTo XWalk (in) | 71 | N/A | B 2 DistanceTo XWalk (in) | N/A |

Possible Solutions: Replace Signal Push Button With APS Button. Remove & Relocate Sign.

OC Std/PROW: MUTCD 4e.08, R404.2, R404.3

Total Cost: \$ 650
