# Access Compliance Report Public Rights-of-Way (Pedestrian Signals)

Main Street: VALENCIA\_AVE Cross Street: CARBON\_CANYON\_RD Location: NE

ADA ID: SGAT210920090119 Signal Type: One Push Button-APS Overall Compliance: No Severity Scores: BTN 1: 25 BTN 2: N/A No BTN: N/A

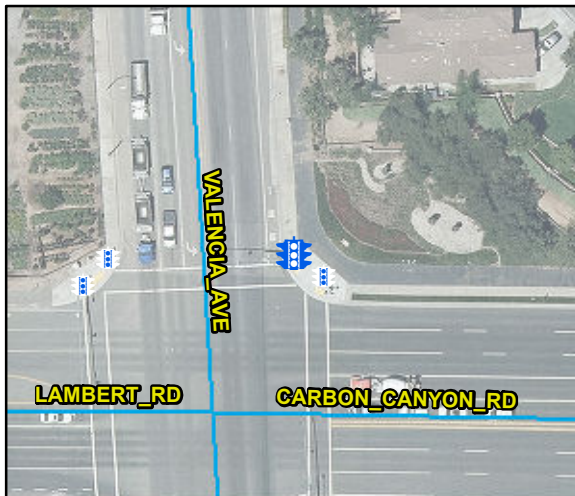
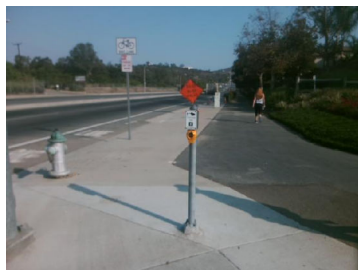
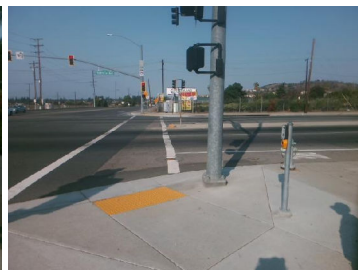
| Compliance | Description | Data | Compliance | Description | Data |
|---|---|---|---|---|---|
| No B 1 Clear Floor Space Slope (%) | 7 | N/A | B 2 Clear Floor Space Slope (%) | N/A | |
| No B 1 Clear Floor Space XSlope (%) | 5.7 | N/A | B 2 Clear Floor Space XSlope (%) | N/A | |
| No B 1 DistanceTo Curb (in) | 110 | N/A | B 2 DistanceTo Curb (in) | N/A | |

Possible Solutions: Replace Signal Push Button With APS Button. Remove & Relocate Sign.
