# Access Compliance Report Public Rights-of-Way (Pedestrian Signals)

Main Street: VALENCIA\_AVE Cross Street: ROSE\_DR Location: SE

ADA ID: SGAT210920142114 Signal Type: One Push Button-APS Overall Compliance: No Severity Scores: BTN 1: 25 BTN 2: N/A No BTN: N/A

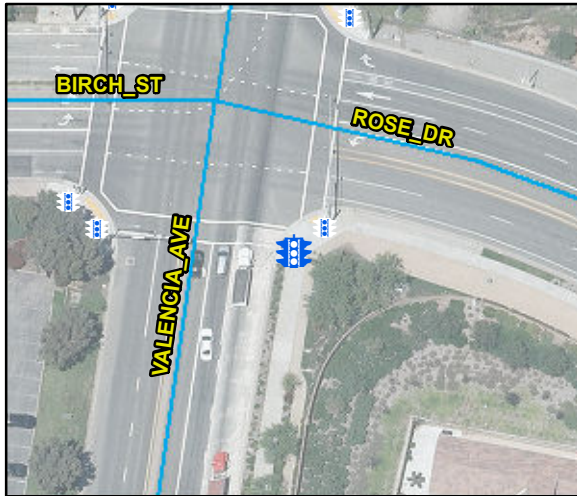
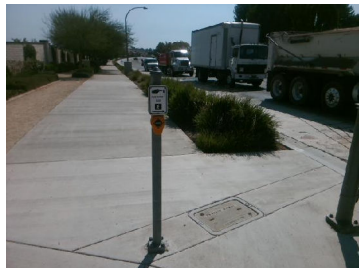
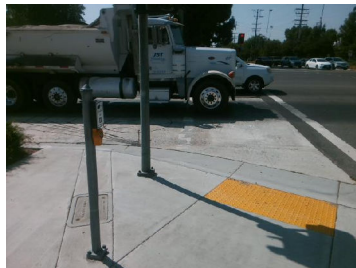
| Compliance | Description | Data | Compliance | Description | Data |
|---|---|---|---|---|---|
| No B 1 Clear Floor Space XSlope (%) | 2.7 | N/A | B 2 Clear Floor Space XSlope (%) | N/A | |
| No B 1 DistanceTo Curb (in) | 103 | N/A | B 2 DistanceTo Curb (in) | N/A | |

Possible Solutions: Replace Signal Push Button With APS Button. Remove & Relocate Sign.
