# Access Compliance Report Public Rights-of-Way (Pedestrian Signals)

Main Street: VALENCIA\_AVE Cross Street: ROSE\_DR Location: NE

ADA ID: SGAT210920144129 Signal Type: One Push Button-APS Overall Compliance: No Severity Scores: BTN 1: 25 BTN 2: N/A No BTN: N/A

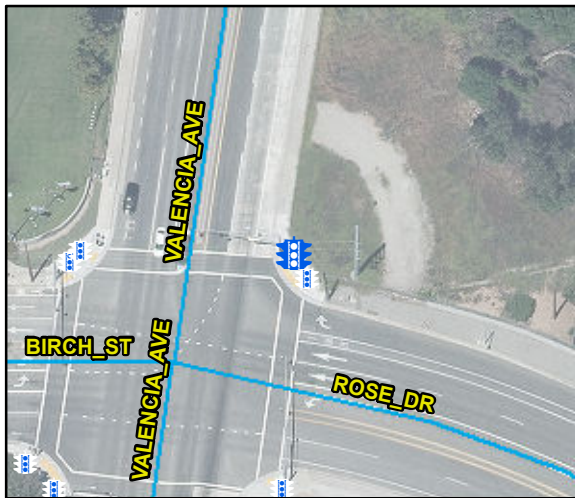
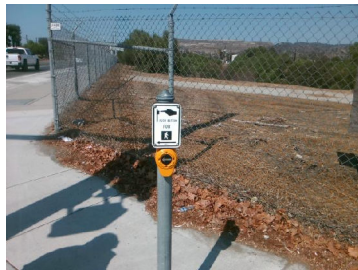
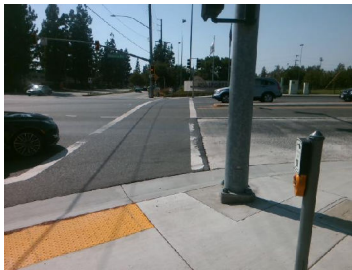
| Compliance | Description | Data | Compliance | Description | Data |
|---|---|---|---|---|---|
| No B 1 Clear Floor Space Slope (%) | 3 | N/A | B 2 Clear Floor Space Slope (%) | N/A | |
| No B 1 Clear Floor Space XSlope (%) | 4.9 | N/A | B 2 Clear Floor Space XSlope (%) | N/A | |
| No B 1 DistanceTo Curb (in) | 112 | N/A | B 2 DistanceTo Curb (in) | N/A | |

Possible Solutions: Replace Signal Push Button With APS Button. Remove & Relocate Sign.

OC Std/PROW: MUTCD 4e.08, R404.2, R404.3
