# Access Compliance Report Public Rights-of-Way (Pedestrian Signals)

Main Street: BIRCH\_ST Cross Street: VALENCIA\_AVE Location: NW

ADA ID: SGAT210920144744 Signal Type: One Push Button-APS Overall Compliance: No Severity Scores: BTN 1: 25 BTN 2: N/A No BTN: N/A

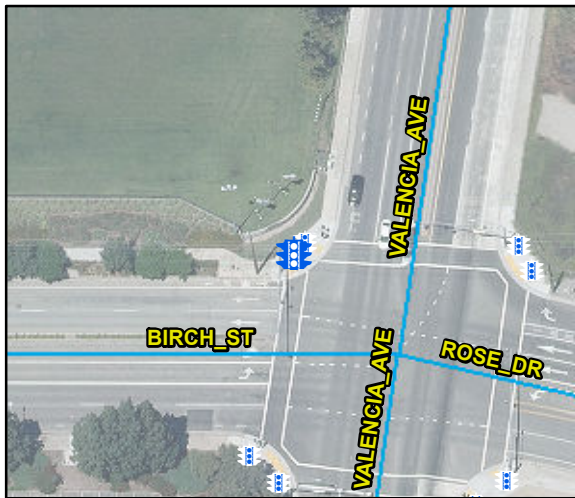
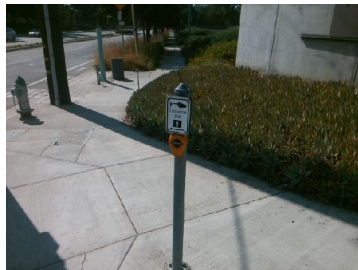
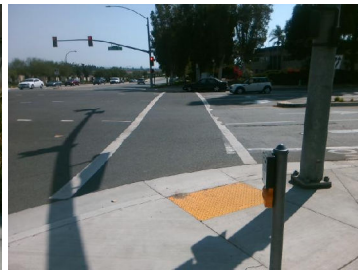
| Compliance | Description | Data | Compliance | Description | Data |
|---|---|---|---|---|---|
| No B 1 Clear Floor Space XSlope (%) | | 6.8 | N/A | B 2 Clear Floor Space XSlope (%) | N/A |
| No B 1 DistanceTo Curb (in) | | 102 | N/A | B 2 DistanceTo Curb (in) | N/A |

Possible Solutions: Replace Signal Push Button With APS Button. Remove & Relocate Sign.

OC Std/PROW: , MUTCD 4e.08, R404.2
