# Access Compliance Report Public Rights-of-Way (Pedestrian Signals)

Main Street: **OLD\_RANCH\_RD** Cross Street: **FAIRMONT\_BLV** Location: **NW**

ADA ID: **SGAT210921145540** Signal Type: **One Push Button-Non APS** Overall Compliance: **No** Severity Scores: **BTN 1: 35** **BTN 2: N/A** **No BTN: N/A**

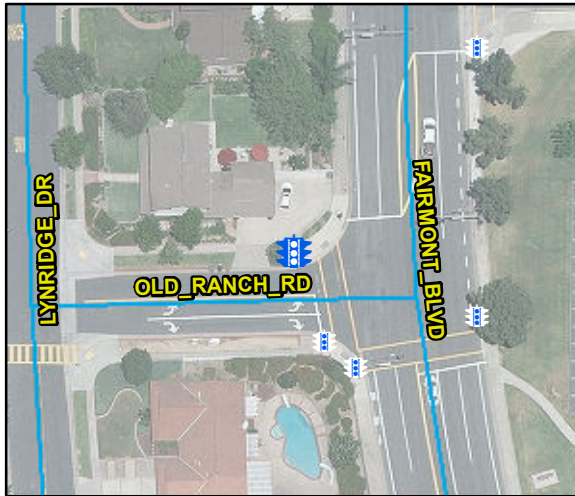
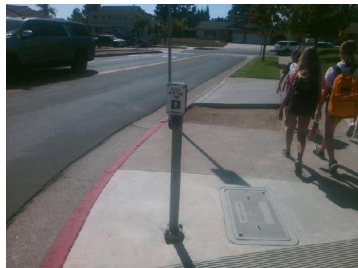
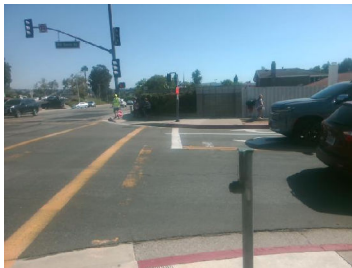
| Compliance | Description | Data | Compliance | Description | Data |
|---|---|---|---|---|---|
| <b>No</b> | B 1 Clear Floor Space XSlope (%) | <b>4.6</b> | <b>N/A</b> | B 2 Clear Floor Space XSlope (%) | <b>N/A</b> |
| <b>No</b> | B 1 DistanceTo XWalk (in) | <b>87</b> | <b>N/A</b> | B 2 DistanceTo XWalk (in) | <b>N/A</b> |

| <b>No</b> | B 1 Pilot Light? | <b>No</b> | <b>N/A</b> | B 2 Pilot Light? | <b>N/A</b> |

Possible Solutions: Replace Signal Push Button With APS Button. Remove & Relocate Sign.

OC Std/PROW: **MUTCD 4e.08, R404.2**

Total Cost: \$ **650**
