# Access Compliance Report Public Rights-of-Way (Pedestrian Signals)

Main Street: FUTURA\_DR Cross Street: FAIRMONT\_BLV Location: SE

ADA ID: SGAT210921152200 Signal Type: One Push Button-Non APS Overall Compliance: No Severity Scores: BTN 1: 35 BTN 2: N/A No BTN: N/A

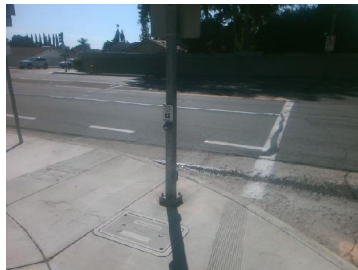
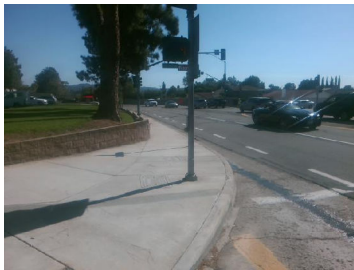
| Compliance | Description | Data | Compliance | Description | Data |
|---|---|---|---|---|---|
| No | B 1 Clear Floor Space Slope (%) | 4.9 | N/A | B 2 Clear Floor Space Slope (%) | N/A |
| No | B 1 Clear Floor Space XSlope (%) | 4 | N/A | B 2 Clear Floor Space XSlope (%) | N/A |

| No | B 1 Pilot Light? | No | N/A | B 2 Pilot Light? | N/A |

Possible Solutions: Replace Signal Push Button With APS Button. Remove and Replace Clear Space.

OC Std/PROW: R404.2, R404.3, MUTCD 4e.08
