# Access Compliance Report Public Rights-of-Way (Pedestrian Signals)

Main Street: **KELLOGG\_DR** Cross Street: **MOUNTAIN\_VIEW\_AVE** Location: **S**

ADA ID: **SGAT210922121351** Signal Type: **One Push Button-Non APS** Overall Compliance: **No** Severity Scores: **BTN 1: 35** **BTN 2: N/A** **No BTN: N/A**

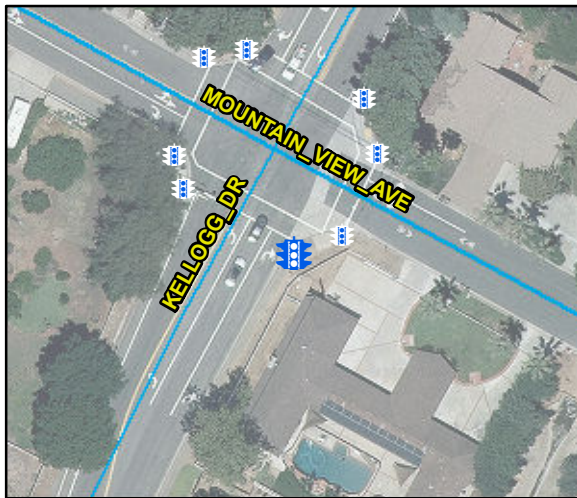
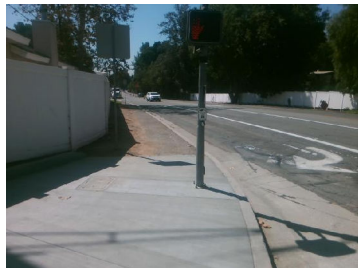
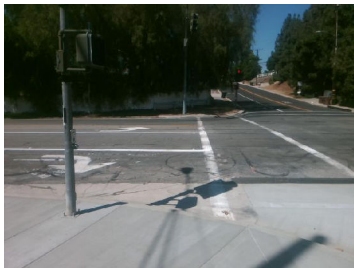
| Compliance | Description | Data | Compliance | Description | Data |
|---|---|---|---|---|---|
| <b>No</b> | B 1 Clear Floor Space XSlope (%) | <b>2.8</b> | <b>N/A</b> | B 2 Clear Floor Space XSlope (%) | <b>N/A</b> |
| <b>No</b> | B 1 DistanceTo XWalk (in) | <b>72</b> | <b>N/A</b> | B 2 DistanceTo XWalk (in) | <b>N/A</b> |

| <b>No</b> | B 1 Pilot Light? | <b>No</b> | <b>N/A</b> | B 2 Pilot Light? | <b>N/A</b> |

Possible Solutions: Replace Signal Push Button With APS Button. Remove & Relocate Sign.

OC Std/PROW: **MUTCD 4e.08, R404.2**

Total Cost: \$ **650**
