# Access Compliance Report Public Rights-of-Way (Pedestrian Signals)

Main Street: MOUNTAIN\_VIEW\_AVE Cross Street: KELLOGG\_DR Location: S

ADA ID: SGAT210922121621 Signal Type: One Push Button-Non APS Overall Compliance: No Severity Scores: BTN 1: 35 BTN 2: N/A No BTN: N/A

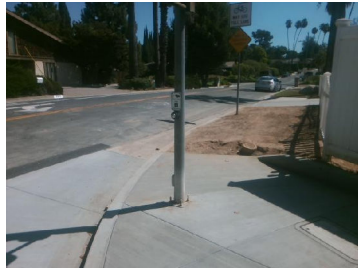
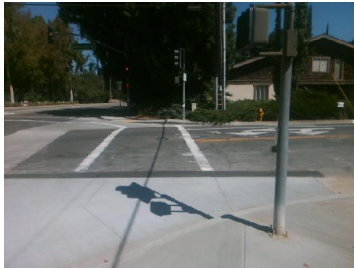
| No B 1 Pilot Light? | No | N/A B 2 Pilot Light? | N/A |

| Compliance | Description | Data | Compliance | Description | Data |
|---|---|---|---|---|---|
| No B 1 Clear Floor Space Slope (%) | 2.2 | N/A | B 2 Clear Floor Space Slope (%) | N/A | |

Possible Solutions: Replace Signal Push Button With APS Button. Remove and Replace Clear Space.

Total Cost: \$ 1278
