# Access Compliance Report Public Rights-of-Way (Pedestrian Signals)

Main Street: **KELLOGG\_DR** Cross Street: **MOUNTAIN\_VIEW\_AVE** Location: **E**

ADA ID: **SGAT210922122613** Signal Type: **One Push Button-Non APS** Overall Compliance: **No** Severity Scores: **BTN 1: 60** **BTN 2: N/A** **No BTN: N/A**

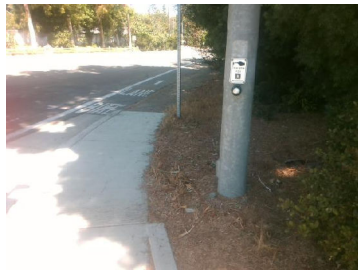
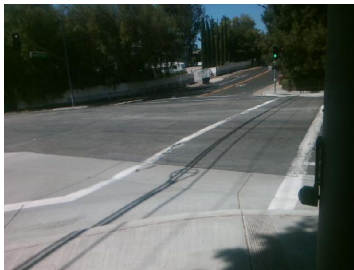
| <b>No</b> B 1 Pilot Light? | <b>No</b> | <b>N/A</b> B 2 Pilot Light? | <b>N/A</b> |

| Compliance | Description | Data | Compliance | Description | Data |
|---|---|---|---|---|---|
| <b>No</b> B 1 Clear Floor Space? | | <b>No</b> | <b>N/A</b> | B 2 Clear Floor Space? | <b>N/A</b> |
| <b>No</b> B 1 PARA Approach Reach (in) | | <b>30</b> | <b>N/A</b> | B 2 PARA Approach Reach (in) | <b>N/A</b> |
| <b>No</b> B 1 DistanceTo Curb (in) | | <b>81</b> | <b>N/A</b> | B 2 DistanceTo Curb (in) | <b>N/A</b> |

Possible Solutions: Replace Signal Push Button With APS Button. Remove & Relocate Sign.

OC Std/PROW: MUTCD 4e.08, R404.3, R404.1, R404.7.1, R404.7.3
