# Access Compliance Report Public Rights-of-Way (Pedestrian Signals)

Main Street: MOUNTAIN\_VIEW\_AVE Cross Street: KELLOGG\_DR Location: N

ADA ID: SGAT210922123909 Signal Type: One Push Button-Non APS Overall Compliance: No Severity Scores: BTN 1: 35 BTN 2: N/A No BTN: N/A

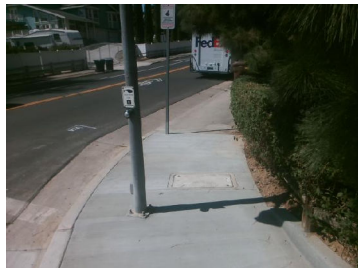
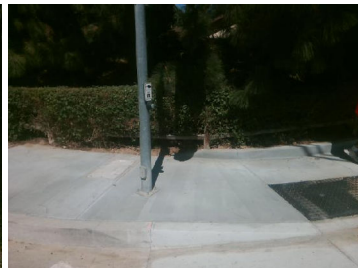
| Compliance | Description | Data | Compliance | Description | Data |
|---|---|---|---|---|---|
| Yes B 1 Clear Floor Space Slope (%) | 1.1 | N/A | B 2 Clear Floor Space Slope (%) | N/A | |
| No B 1 Clear Floor Space XSlope (%) | 3 | N/A | B 2 Clear Floor Space XSlope (%) | N/A | |

Possible Solutions: Replace Signal Push Button With APS Button. Remove and Replace Clear Space.

OC Std/PROW: R404.2, MUTCD 4e.08
