# Access Compliance Report Public Rights-of-Way (Pedestrian Signals)

Main Street: **KELLOGG\_DR** Cross Street: **MOUNTAIN\_VIEW\_AVE** Location: **W**

ADA ID: **SGAT210922125440** Signal Type: **One Push Button-Non APS** Overall Compliance: **No** Severity Scores: **BTN 1: 35** **BTN 2: N/A** **No BTN: N/A**

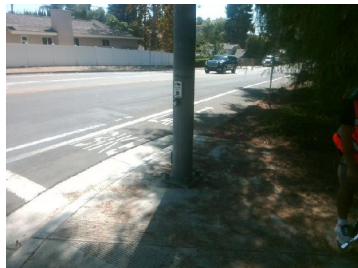
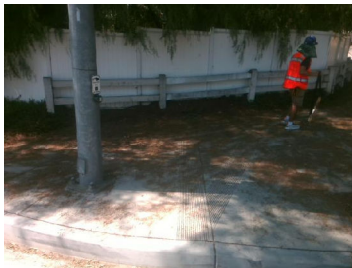
| <b>No</b> B 1 Pilot Light? | <b>No</b> | <b>N/A</b> B 2 Pilot Light? | <b>N/A</b> |

| Compliance | Description | Data | Compliance | Description | Data |
|---|---|---|---|---|---|
| <b>No</b> | B 1 Clear Floor Space XSlope (%) | <b>3</b> | <b>N/A</b> | B 2 Clear Floor Space XSlope (%) | <b>N/A</b> |

**Possible Solutions: Replace Signal Push Button With APS Button. Remove and Replace Clear Space.**

**OC Std/PROW: R404.2, MUTCD 4e.08**
