# Access Compliance Report Public Rights-of-Way (Pedestrian Signals)

Main Street: YORBA\_LINDA\_BLVD Cross Street: YORBA\_LINDA\_BLVD Location: SW

ADA ID: SGAT210923080540 Signal Type: One Push Button-Non APS Overall Compliance: No Severity Scores: BTN 1: 35 BTN 2: N/A No BTN: N/A

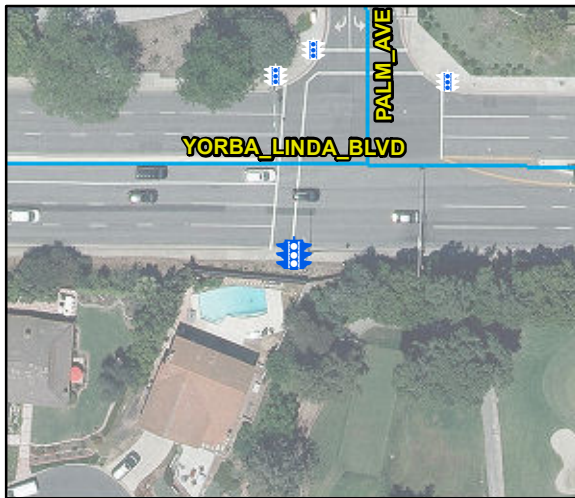
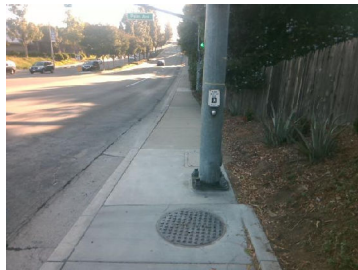
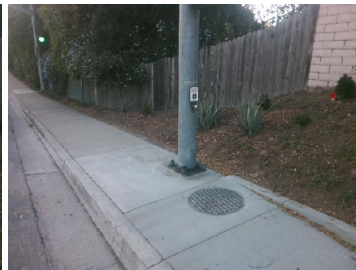
Surveyor Notes: Manhole in clear space

| Compliance | Description | Data | Compliance | Description | Data |
|---|---|---|---|---|---|
| No | B 1 Clear Floor Space Slope (%) | 6.9 | N/A | B 2 Clear Floor Space Slope (%) | N/A |
| No | B 1 Clear Floor Space XSlope (%) | 2.2 | N/A | B 2 Clear Floor Space XSlope (%) | N/A |
| No | B 1 DistanceTo XWalk (in) | 74 | N/A | B 2 DistanceTo XWalk (in) | N/A |

Possible Solutions: Replace Signal Push Button With APS Button. Remove & Relocate Sign.
