# Access Compliance Report Public Rights-of-Way (Pedestrian Signals)

Main Street: CHAPMAN\_AVE Cross Street: ORANGE\_PARK\_BLDV Location: S

ADA ID: SGAT210927091334 Signal Type: One Push Button-Non APS Overall Compliance: No Severity Scores: BTN 1: 60 BTN 2: N/A No BTN: N/A

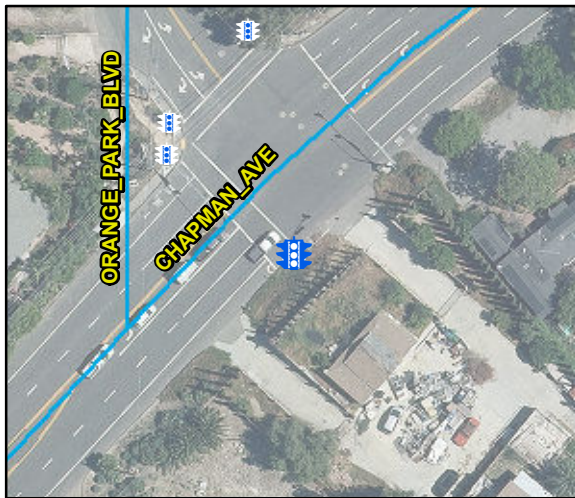
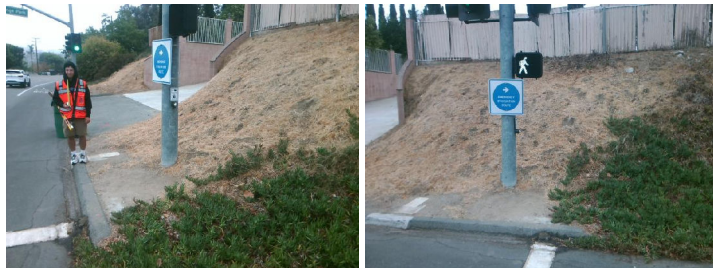
| Compliance | Description | Data | Compliance | Description | Data |
|---|---|---|---|---|---|
| No | B 1 Clear Floor Space? | No | N/A | B 2 Clear Floor Space? | N/A |
| No | B 1 PARA Approach Reach (in) | 60 | N/A | B 2 PARA Approach Reach (in) | N/A |

| No | B 1 Pilot Light? | No | N/A | B 2 Pilot Light? | N/A |

Possible Solutions: Replace Signal Push Button With APS Button. Provide PAR As Indicated. Provide Clear Space.

OC Std/PROW: R404.3, R404.1, R404.7.1, R404.7.3, MUTCD 4e.08
