# Access Compliance Report Public Rights-of-Way (Pedestrian Signals)

Main Street: RANCHO\_SANTIAGO\_BLV Cross Street: SPRING\_ST Location: NE

ADA ID: SGAT210928090520 Signal Type: One Push Button-Non APS Overall Compliance: No Severity Scores: BTN 1: 25 BTN 2: N/A No BTN: N/A

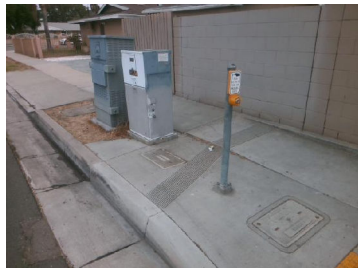
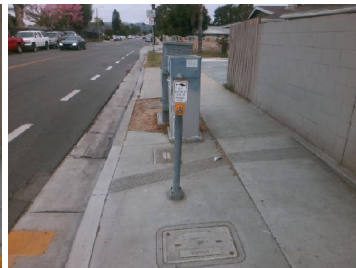
| Compliance | Description | Data | Compliance | Description | Data |
|---|---|---|---|---|---|
| No | B 1 Clear Floor Space XSlope (%) | 3.2 | N/A | B 2 Clear Floor Space XSlope (%) | N/A |

Possible Solutions: Remove and Replace Clear Space.

OC Std/PROW: R404.2

Total Cost: \$ 378
