# Access Compliance Report Public Rights-of-Way (Pedestrian Signals)

Main Street: HEWES\_ST Cross Street: E\_SPRING\_ST Location: SE

ADA ID: SGAT210928125532 Signal Type: One Push Button-Non APS Overall Compliance: No Severity Scores: BTN 1: 35 BTN 2: N/A No BTN: N/A

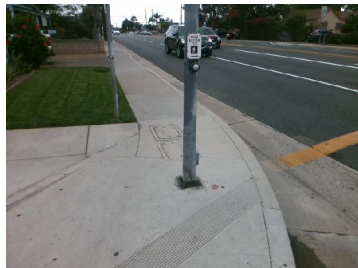
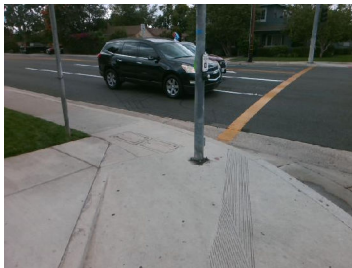
| No B 1 Pilot Light? | No | N/A B 2 Pilot Light? | N/A |

| Compliance | Description | Data | Compliance | Description | Data |
|---|---|---|---|---|---|
| No B 1 Clear Floor Space XSlope (%) | | 5.1 | N/A | B 2 Clear Floor Space XSlope (%) | N/A |

Possible Solutions: Replace Signal Push Button With APS Button. Remove and Replace Clear Space.

OC Std/PROW: R404.2, MUTCD 4e.08
