# Access Compliance Report Public Rights-of-Way (Pedestrian Signals)

Main Street: **E\_SPRING\_ST** Cross Street: **HEWES\_ST** Location: **SE**

ADA ID: **SGAT210928125703** Signal Type: **One Push Button-Non APS** Overall Compliance: **No** Severity Scores: **BTN 1: 35** **BTN 2: N/A** **No BTN: N/A**

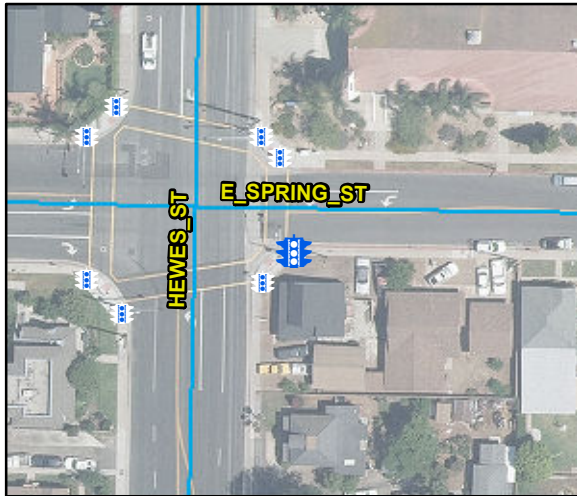
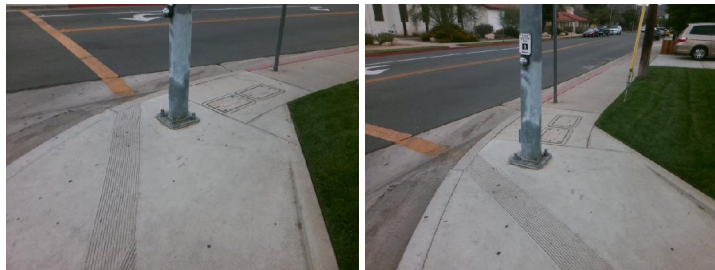
| Compliance | Description | Data | Compliance | Description | Data |
|---|---|---|---|---|---|
| <b>No</b> | B 1 Clear Floor Space XSlope (%) | <b>3.2</b> | <b>N/A</b> | B 2 Clear Floor Space XSlope (%) | <b>N/A</b> |

Possible Solutions: Replace Signal Push Button With APS Button. Remove and Replace Clear Space.
