# Access Compliance Report Public Rights-of-Way (Pedestrian Signals)

Main Street: **E\_SPRING\_ST** Cross Street: **HEWES\_ST** Location: **NE**

ADA ID: **SGAT210928130205** Signal Type: **One Push Button-Non APS** Overall Compliance: **No** Severity Scores: **BTN 1: 35** **BTN 2: N/A** **No BTN: N/A**

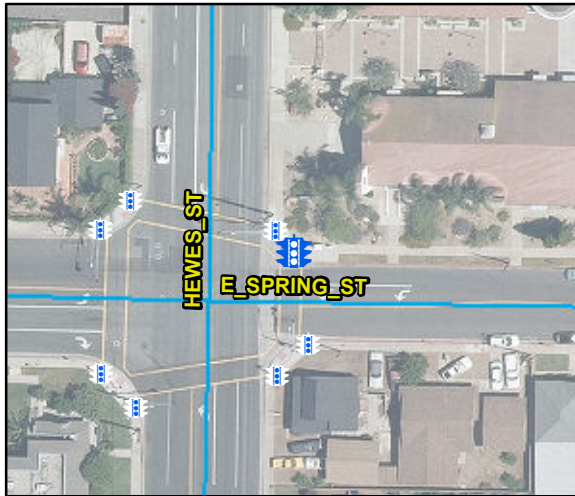
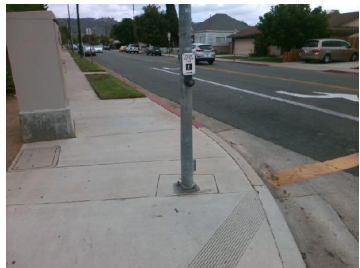
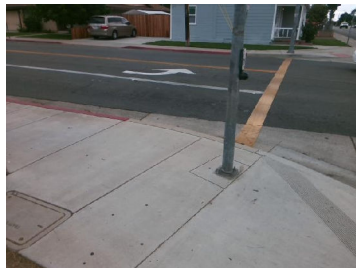
| <b>No</b> B 1 Pilot Light? | <b>No</b> | <b>N/A</b> B 2 Pilot Light? | <b>N/A</b> |

| Compliance | Description | Data | Compliance | Description | Data |
|---|---|---|---|---|---|
| <b>No</b> | B 1 Clear Floor Space Slope (%) | <b>2.3</b> | <b>N/A</b> | B 2 Clear Floor Space Slope (%) | <b>N/A</b> |

Possible Solutions: Replace Signal Push Button With APS Button. Remove and Replace Clear Space.

OC Std/PROW: **R404.2, R404.3, MUTCD 4e.08**
