# Access Compliance Report Public Rights-of-Way (Pedestrian Signals)

Main Street: **E\_SPRING\_ST** Cross Street: **HEWES\_ST** Location: **NW**

ADA ID: **SGAT210929090920** Signal Type: **One Push Button-Non APS** Overall Compliance: **No** Severity Scores: **BTN 1: 35** **BTN 2: N/A** **No BTN: N/A**

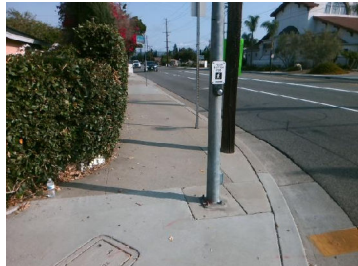
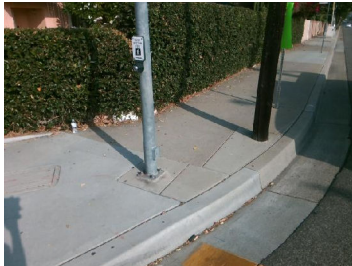
| Compliance | Description | Data | Compliance | Description | Data |
|---|---|---|---|---|---|
| <b>No</b> | B 1 Clear Floor Space Slope (%) | <b>3.5</b> | <b>N/A</b> | B 2 Clear Floor Space Slope (%) | <b>N/A</b> |
| <b>No</b> | B 1 Clear Floor Space XSlope (%) | <b>2.7</b> | <b>N/A</b> | B 2 Clear Floor Space XSlope (%) | <b>N/A</b> |

| <b>No</b> | B 1 Pilot Light? | <b>No</b> | <b>N/A</b> | B 2 Pilot Light? | <b>N/A</b> |

**Possible Solutions: Replace Signal Push Button With APS Button. Remove and Replace Clear Space.**
