# Access Compliance Report Public Rights-of-Way (Pedestrian Signals)

Main Street: **E\_SPRING\_ST** Cross Street: **HEWES\_ST** Location: **NW**

ADA ID: **SGAT210929091340** Signal Type: **One Push Button-Non APS** Overall Compliance: **No** Severity Scores: **BTN 1: 10** **BTN 2: N/A** **No BTN: N/A**

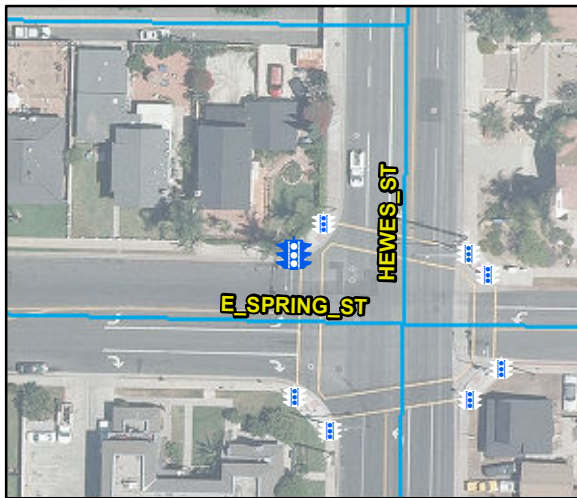
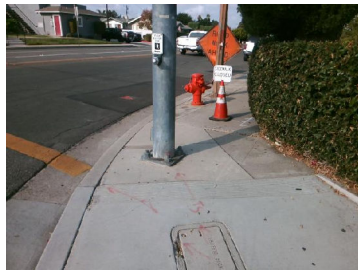
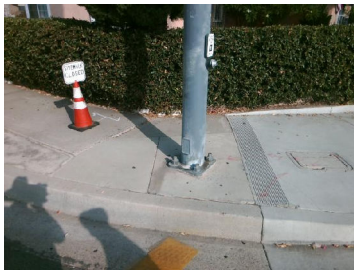
| <b>No</b> B 1 Pilot Light? | <b>No</b> | <b>N/A</b> B 2 Pilot Light? | <b>N/A</b> |

Possible Solutions: Replace Signal Push Button With APS Button.
