# Access Compliance Report Public Rights-of-Way (Pedestrian Signals)

Main Street: **CHAPMAN\_AVE** Cross Street: **RANCHO\_SANTIAGO\_BVLD** Location: **NW**

ADA ID: **SGAT210929104033** Signal Type: **One Push Button-Non APS** Overall Compliance: **No** Severity Scores: **BTN 1: 35** **BTN 2: N/A** **No BTN: N/A**

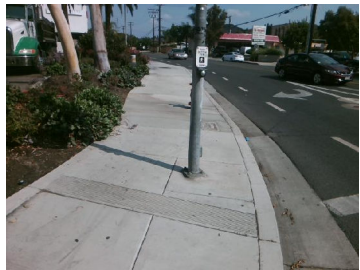
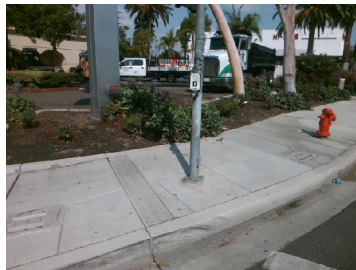
| <b>No</b> B 1 Pilot Light? | <b>No</b> | <b>N/A</b> B 2 Pilot Light? | <b>N/A</b> |

| Compliance | Description | Data | Compliance | Description | Data |
|---|---|---|---|---|---|
| <b>No</b> | B 1 Clear Floor Space Slope (%) | <b>3.7</b> | <b>N/A</b> | B 2 Clear Floor Space Slope (%) | <b>N/A</b> |

Possible Solutions: Replace Signal Push Button With APS Button. Remove and Replace Clear Space.
