# Access Compliance Report Public Rights-of-Way (Pedestrian Signals)

Main Street: RANCHO\_SANTIAGO\_BLV Cross Street: E\_CHAPMAN\_AVE Location: NE

ADA ID: SGAT210929104815 Signal Type: One Push Button-Non APS Overall Compliance: No Severity Scores: BTN 1: 10 BTN 2: N/A No BTN: N/A

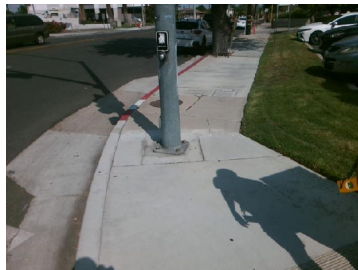
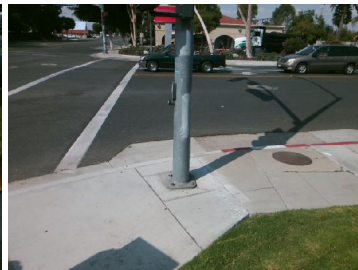
| N/A Is Button 1 APS or Non-APS? | NonAPS | N/A Is Button 2 APS or Non-APS? | N/A |
| No B 1 Pilot Light? | No | N/A B 2 Pilot Light? | N/A |

Possible Solutions: Replace Signal Push Button With APS Button.

OC Std/PROW: MUTCD 4e.08

Total Cost: \$ 900
