# Access Compliance Report Public Rights-of-Way (Pedestrian Signals)

Main Street: **S\_HEWES\_ST** Cross Street: **CHAPMAN\_AVE** Location: **SW**

ADA ID: **SGAT210929131814** Signal Type: **One Push Button-Non APS** Overall Compliance: **No** Severity Scores: **BTN 1: 10** **BTN 2: N/A** **No BTN: N/A**

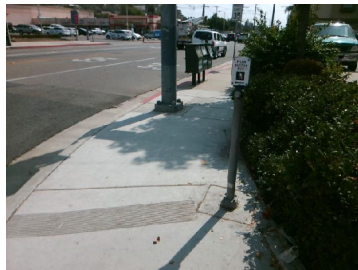
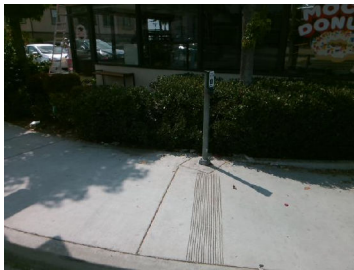
| <b>No</b> B 1 Pilot Light? | <b>No</b> | <b>N/A</b> B 2 Pilot Light? | <b>N/A</b> |

| Compliance | Description | Data | Compliance | Description | Data |
|---|---|---|---|---|---|
| <b>No</b> | B 1 DistanceTo Curb (in) | <b>76</b> | <b>N/A</b> | B 2 DistanceTo Curb (in) | <b>N/A</b> |

Possible Solutions: Replace Signal Push Button With APS Button. Remove & Relocate Sign.
