# Access Compliance Report Public Rights-of-Way (Pedestrian Signals)

Main Street: **S\_HEWES\_ST** Cross Street: **CHAPMAN\_AVE** Location: **SW**

ADA ID: **SGAT210929132411** Signal Type: **One Push Button-Non APS** Overall Compliance: **No** Severity Scores: **BTN 1: 35** **BTN 2: N/A** **No BTN: N/A**

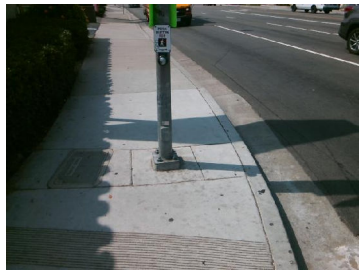
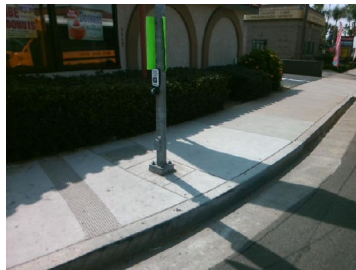
| <b>No</b> B 1 Pilot Light? | <b>No</b> | <b>N/A</b> B 2 Pilot Light? | <b>N/A</b> |

| Compliance | Description | Data | Compliance | Description | Data |
|---|---|---|---|---|---|
| <b>No</b> | B 1 Clear Floor Space Slope (%) | <b>2.5</b> | <b>N/A</b> | B 2 Clear Floor Space Slope (%) | <b>N/A</b> |

Possible Solutions: Replace Signal Push Button With APS Button. Remove and Replace Clear Space.
