# Access Compliance Report Public Rights-of-Way (Pedestrian Signals)

Main Street: HEWES\_AVE Cross Street: HEWES\_AVE Location: SE

ADA ID: SGAT211015094805 Signal Type: One Push Button-Non APS Overall Compliance: No Severity Scores: BTN 1: 25 BTN 2: N/A No BTN: N/A

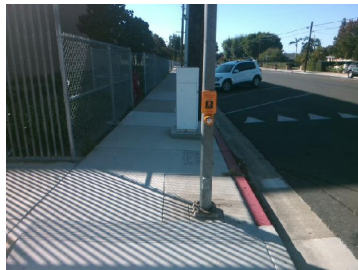
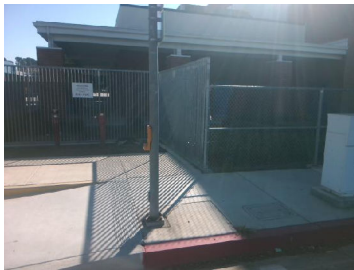
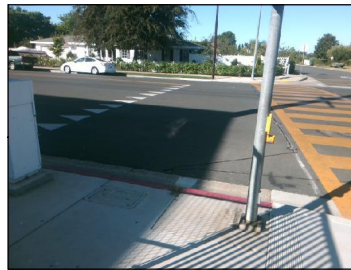
| Compliance | Description | Data | Compliance | Description | Data |
|---|---|---|---|---|---|
| No | B 1 Clear Floor Space Slope (%) | 3.1 | N/A | B 2 Clear Floor Space Slope (%) | N/A |

Possible Solutions: Remove and Replace Clear Space.

OC Std/PROW: R404.2, R404.3

Total Cost: \$ 378
