# Access Compliance Report Public Rights-of-Way (Pedestrian Signals)

Main Street: HEWES\_AVE Cross Street: SPAULDING\_AVE Location: SW

ADA ID: SGAT211015095902 Signal Type: One Push Button-Non APS Overall Compliance: No Severity Scores: BTN 1: 25 BTN 2: N/A No BTN: N/A

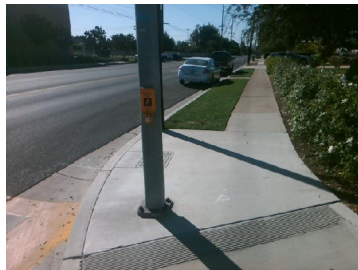
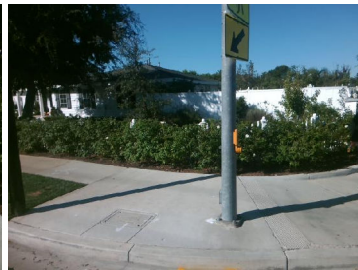
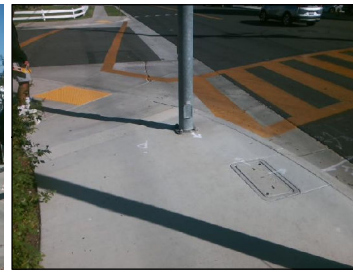
| Compliance | Description | Data | Compliance | Description | Data |
|---|---|---|---|---|---|
| No | B 1 Clear Floor Space Slope (%) | 3.9 | N/A | B 2 Clear Floor Space Slope (%) | N/A |

Possible Solutions: Remove and Replace Clear Space.
