# Access Compliance Report Public Rights-of-Way (Pedestrian Signals)

Main Street: FAIRHAVEN\_AVE Cross Street: PROSPECT\_AVE Location: SE

ADA ID: SGAT211021103938 Signal Type: One Push Button-Non APS Overall Compliance: No Severity Scores: BTN 1: 35 BTN 2: N/A No BTN: N/A

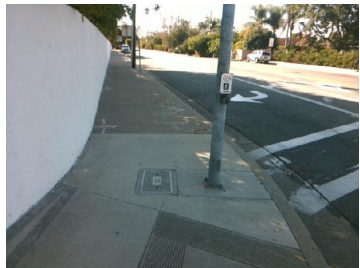
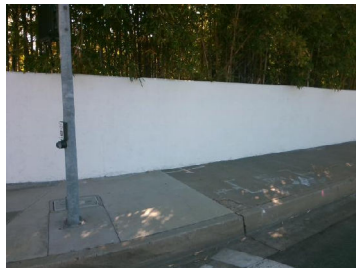
| No B 1 Pilot Light? | No | N/A B 2 Pilot Light? | N/A |

| Compliance | Description | Data | Compliance | Description | Data |
|---|---|---|---|---|---|
| No | B 1 Clear Floor Space Slope (%) | 4.2 | N/A | B 2 Clear Floor Space Slope (%) | N/A |
| No | B 1 Clear Floor Space XSlope (%) | 2.9 | N/A | B 2 Clear Floor Space XSlope (%) | N/A |

Possible Solutions: Replace Signal Push Button With APS Button. Remove and Replace Clear Space.

OC Std/PROW: R404.2, R404.3, MUTCD 4e.08
