# Access Compliance Report Public Rights-of-Way (Pedestrian Signals)

Main Street: FAIRHAVEN\_AVE Cross Street: PROSPECT\_AVE Location: SE

ADA ID: SGAT211021104135 Signal Type: One Push Button-Non APS Overall Compliance: No Severity Scores: BTN 1: 35 BTN 2: N/A No BTN: N/A

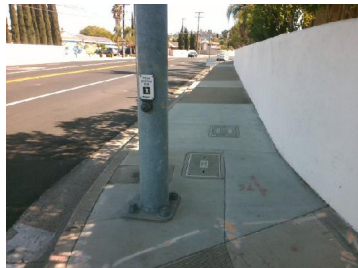
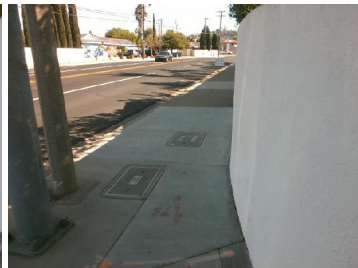
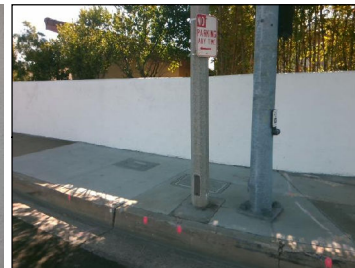
| Compliance | Description | Data | Compliance | Description | Data |
|---|---|---|---|---|---|
| No B 1 Clear Floor Space XSlope (%) | 2.1 | N/A | B 2 Clear Floor Space XSlope (%) | N/A | |

Possible Solutions: Replace Signal Push Button With APS Button. Remove and Replace Clear Space.
