# Access Compliance Report Public Rights-of-Way (Pedestrian Signals)

Main Street: FAIRHAVEN\_AVE Cross Street: PROSPECT\_ST Location: NW

ADA ID: SGAT211022103442 Signal Type: One Push Button-Non APS Overall Compliance: No Severity Scores: BTN 1: 35 BTN 2: N/A No BTN: N/A

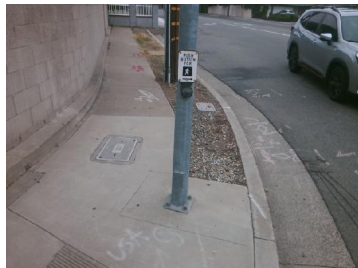
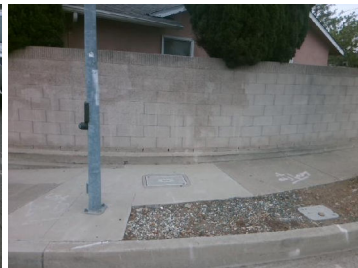
| Compliance | Description | Data | Compliance | Description | Data |
|---|---|---|---|---|---|
| No | B 1 Clear Floor Space Slope (%) | 3.2 | N/A | B 2 Clear Floor Space Slope (%) | N/A |

Possible Solutions: Replace Signal Push Button With APS Button. Remove and Replace Clear Space.
