# Access Compliance Report Public Rights-of-Way (Pedestrian Signals)

Main Street: RED\_HILL\_AVE Cross Street: IRVINE\_BLVD Location: SE

ADA ID: SGAT211027085739 Signal Type: One Push Button-APS Overall Compliance: No Severity Scores: BTN 1: 45 BTN 2: N/A No BTN: N/A

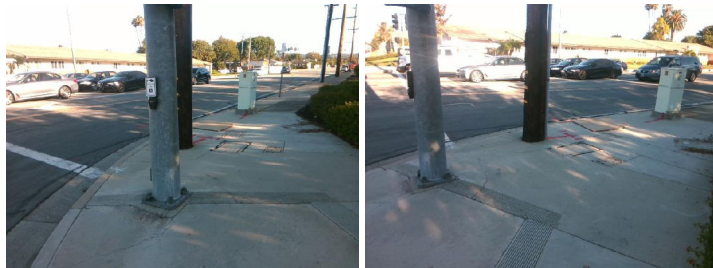
| Compliance | Description | Data | Compliance | Description | Data |
|---|---|---|---|---|---|
| No | B 1 Clear Floor Space Slope (%) | 3.8 | N/A | B 2 Clear Floor Space Slope (%) | N/A |
| No | B 1 Height (in) | 49 | N/A | B 2 Height (in) | N/A |

Possible Solutions: Adjust Signal Button Height. Remove and Replace Clear Space.
