# Access Compliance Report Public Rights-of-Way (Pedestrian Signals)

Main Street: RED\_HILL\_AVE Cross Street: IRVINE\_BLVD Location: SE

ADA ID: SGAT211027090022 Signal Type: One Push Button-APS Overall Compliance: No Severity Scores: BTN 1: 25 BTN 2: N/A No BTN: N/A

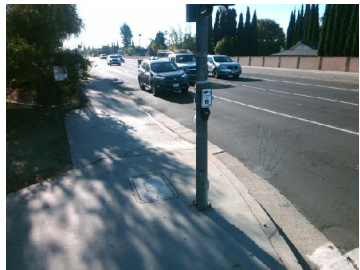
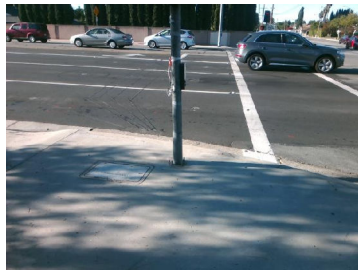
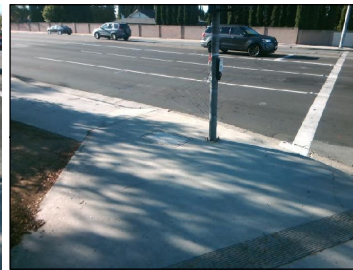
| Compliance | Description | Data | Compliance | Description | Data |
|---|---|---|---|---|---|
| No B 1 Clear Floor Space XSlope (%) | 4.4 | N/A | N/A | B 2 Clear Floor Space XSlope (%) | N/A |

Possible Solutions: Remove and Replace Clear Space.

OC Std/PROW: R404.2

Total Cost: \$ 378
