# Access Compliance Report Public Rights-of-Way (Pedestrian Signals)

Main Street: IRVINE\_BLVD Cross Street: RED\_HILL\_AVE Location: SW

ADA ID: SGAT211027090558 Signal Type: One Push Button-APS Overall Compliance: No Severity Scores: BTN 1: 25 BTN 2: N/A No BTN: N/A

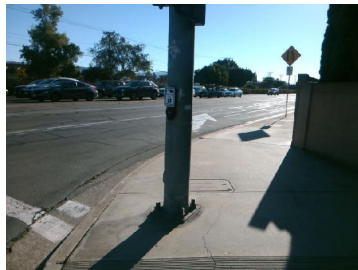
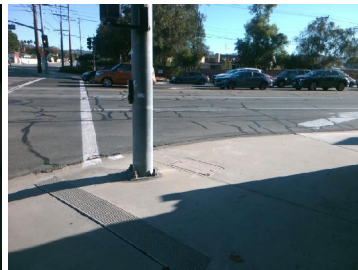
| Compliance | Description | Data | Compliance | Description | Data |
|---|---|---|---|---|---|
| No | B 1 Clear Floor Space Slope (%) | 3.5 | N/A | B 2 Clear Floor Space Slope (%) | N/A |

Possible Solutions: Remove and Replace Clear Space.

OC Std/PROW: R404.2, R404.3

Total Cost: \$ 378
