# Access Compliance Report Public Rights-of-Way (Pedestrian Signals)

Main Street: IRVINE\_BLV D Cross Street: RED\_HILL\_AVE Location: SW

ADA ID: SGAT211027090737 Signal Type: One Push Button-APS Overall Compliance: No Severity Scores: BTN 1: 25 BTN 2: N/A No BTN: N/A

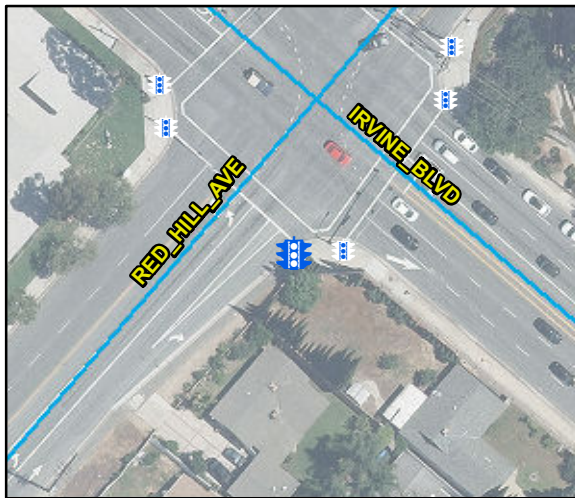
| Compliance | Description | Data | Compliance | Description | Data |
|---|---|---|---|---|---|
| No B 1 Clear Floor Space Slope (%) | 5.7 | N/A | N/A | B 2 Clear Floor Space Slope (%) | N/A |
| No B 1 Clear Floor Space XSlope (%) | 3.6 | N/A | N/A | B 2 Clear Floor Space XSlope (%) | N/A |

Possible Solutions: Remove and Replace Clear Space.

OC Std/PROW: R404.2, R404.3

Total Cost: \$ 378
