# Access Compliance Report

## Public Rights-of-Way

### (Pedestrian Signals)

Main Street: **RED\_HILL\_AVE** Cross Street: **IRVINE\_BLVD** Location: **NW**

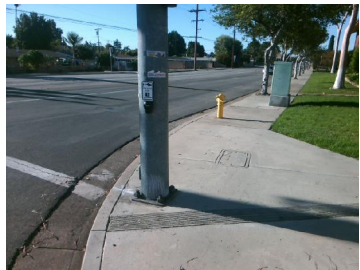
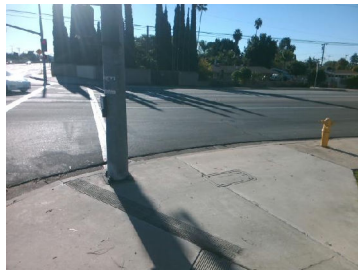
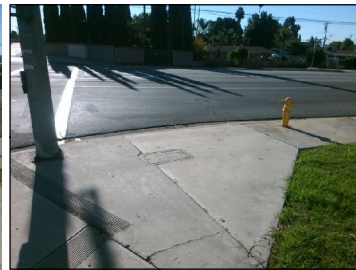
ADA ID: **SGAT211027091234** Signal Type: **One Push Button-APS** Overall Compliance: **No** Severity Scores: **BTN 1: 25** **BTN 2: N/A** **No BTN: N/A**

| Compliance | Description | Data | Compliance | Description | Data |
|---|---|---|---|---|---|
| No B 1 Clear Floor Space XSlope (%) | | 3 | N/A | B 2 Clear Floor Space XSlope (%) | N/A |
| No B 1 DistanceTo Curb (in) | | 13 | N/A | B 2 DistanceTo Curb (in) | N/A |

Possible Solutions: Replace Signal Push Button With APS Button. Remove & Relocate Sign.
