# Access Compliance Report Public Rights-of-Way (Pedestrian Signals)

Main Street: IRVINE\_BLVD Cross Street: IRVINE\_BLVD Location: SW

ADA ID: SGAT211027105622 Signal Type: One Push Button-APS Overall Compliance: No Severity Scores: BTN 1: 25 BTN 2: N/A No BTN: N/A

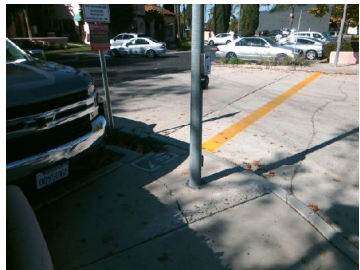
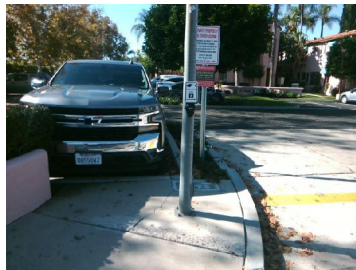
| Compliance | Description | Data | Compliance | Description | Data |
|---|---|---|---|---|---|
| No | B 1 Clear Floor Space? | No | N/A | B 2 Clear Floor Space? | N/A |

Possible Solutions: Provide Clear Space.
