# Access Compliance Report Public Rights-of-Way (Pedestrian Signals)

Main Street: **PROSPECT\_ST** Cross Street: **BOND\_AVE** Location: **E**

ADA ID: **SGAT211028084646** Signal Type: **One Push Button-Non APS** Overall Compliance: **No** Severity Scores: **BTN 1: 35** **BTN 2: N/A** **No BTN: N/A**

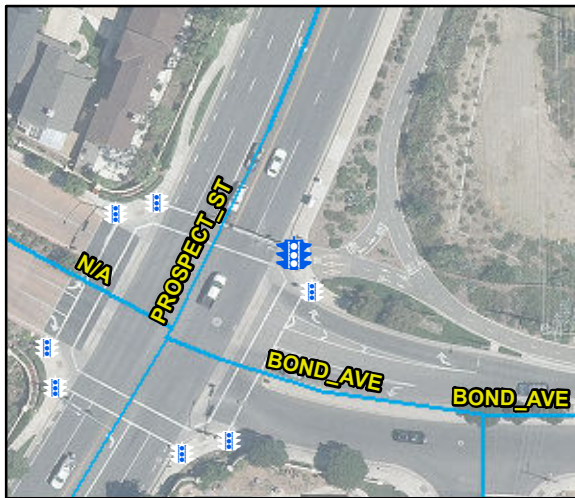
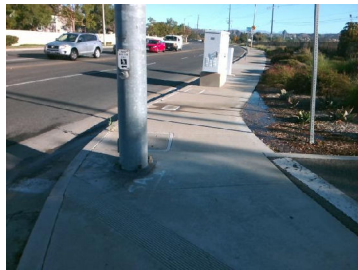
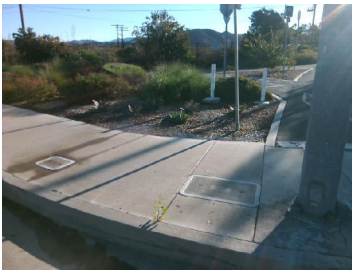
| <b>No</b> B 1 Pilot Light? | <b>No</b> | <b>N/A</b> B 2 Pilot Light? | <b>N/A</b> |

| Compliance | Description | Data | Compliance | Description | Data |
|---|---|---|---|---|---|
| <b>No</b> | B 1 Clear Floor Space Slope (%) | <b>2.1</b> | <b>N/A</b> | B 2 Clear Floor Space Slope (%) | <b>N/A</b> |

Possible Solutions: Replace Signal Push Button With APS Button. Remove and Replace Clear Space.

OC Std/PROW: **R404.2, R404.3, MUTCD 4e.08**
