# Access Compliance Report Public Rights-of-Way (Pedestrian Signals)

Main Street: LINCOLN\_AVE Cross Street: N/A Location: NW

ADA ID: SGAT220126124656 Signal Type: Two Push Buttons-Non APS Overall Compliance: No Severity Scores: BTN 1: 25 BTN 2: 25 No BTN: N/A

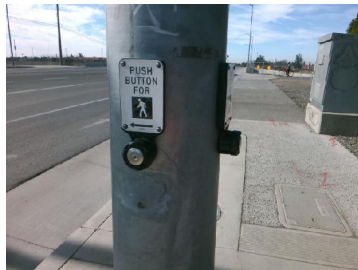
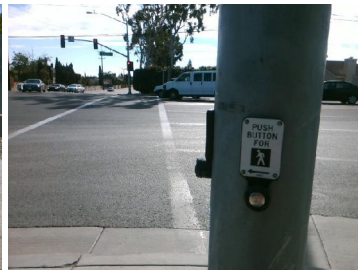
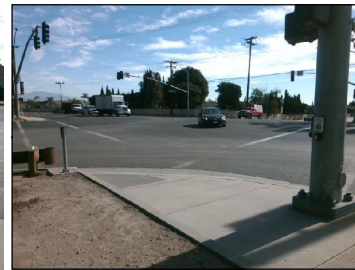
| Compliance | Description | Data | Compliance | Description | Data |
|---|---|---|---|---|---|
| No | B 1 Clear Floor Space Slope (%) | 8.4 | Yes | B 2 Clear Floor Space Slope (%) | 2.1 |
| No | B 1 Clear Floor Space XSlope (%) | 2.8 | No | B 2 Clear Floor Space XSlope (%) | 5.2 |
| No | B 1 DistanceTo Curb (in) | 188 | Yes | B 2 DistanceTo Curb (in) | 36 |

Possible Solutions: Replace Signal Push Button With APS Button. Remove & Relocate Sign. Remove and Replace Clear Space.
