# Access Compliance Report Public Rights-of-Way (Pedestrian Signals)

Main Street: LINCOLN\_AVE Cross Street: ORANGE\_OLIVE\_RD Location: SE

ADA ID: SGAT220127100451 Signal Type: One Push Button-Non APS Overall Compliance: No Severity Scores: BTN 1: 35 BTN 2: N/A No BTN: N/A

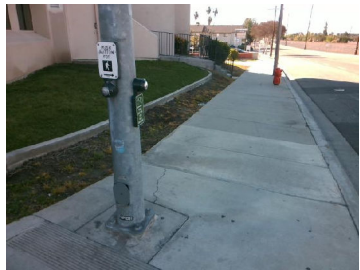
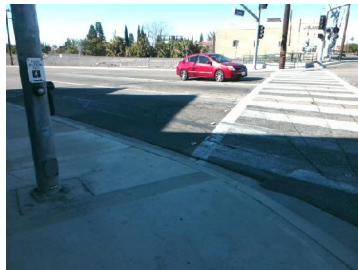
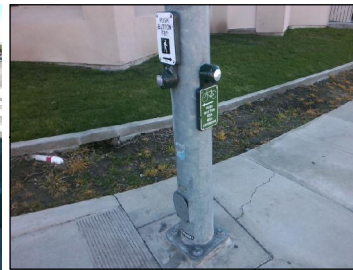
Surveyor Notes: Button 2 for Bike Lane

| Compliance | Description | Data | Compliance | Description | Data |
|---|---|---|---|---|---|
| No | B 1 Clear Floor Space Slope (%) | 6.7 | N/A | B 2 Clear Floor Space Slope (%) | 8.3 |
| No | B 1 Clear Floor Space XSlope (%) | 6.2 | N/A | B 2 Clear Floor Space XSlope (%) | 11.7 |
| No | B 1 Pressure (#) | 8 | N/A | B 2 Pressure (#) | 8 |

| No | B 1 Pilot Light? | No | N/A | B 2 Pilot Light? | No |

Possible Solutions: Replace Signal Push Button With APS Button. Remove and Replace Clear Space.

OC Std/PROW: R404.2, R404.3, R403.4, MUTCD 4e.08
