# Access Compliance Report Public Rights-of-Way (Pedestrian Signals)

Main Street: MESA\_DR Cross Street: IRVINE\_AVE Location: SE

ADA ID: SGAT220128132706 Signal Type: One Push Button-Non APS Overall Compliance: No Severity Scores: BTN 1: 35 BTN 2: N/A No BTN: N/A

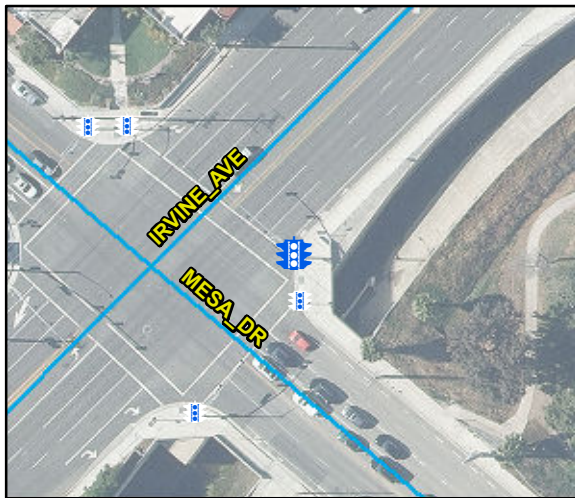
| No B 1 Pilot Light? | No | N/A B 2 Pilot Light? | N/A |

Possible Solutions: Replace Signal Push Button With APS Button. Remove and Replace Clear Space.

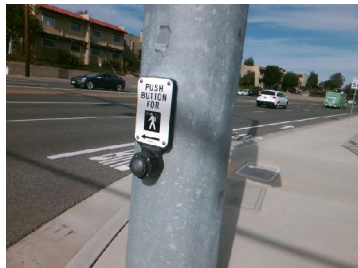
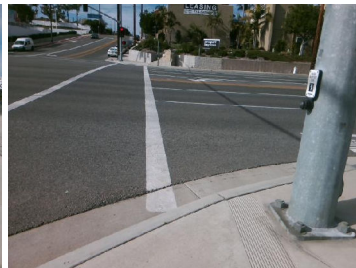
| Compliance | Description | Data | Compliance | Description | Data |
|---|---|---|---|---|---|
| No B 1 Clear Floor Space Slope (%) | 2.5 | N/A | N/A | B 2 Clear Floor Space XSlope (%) | N/A |
| No B 1 Clear Floor Space XSlope (%) | 4.6 | N/A | N/A | B 2 PAR Slope (%) | N/A |
| No B 1 Pressure (#) | 7 | N/A | N/A | B 2 Closed Fist Operation? | N/A |
