# Access Compliance Report Public Rights-of-Way (Pedestrian Signals)

Main Street: MESA\_DR Cross Street: IRVINE\_AVE Location: SE

ADA ID: SGAT220128133042 Signal Type: One Push Button-Non APS Overall Compliance: No Severity Scores: BTN 1: 35 BTN 2: N/A No BTN: N/A

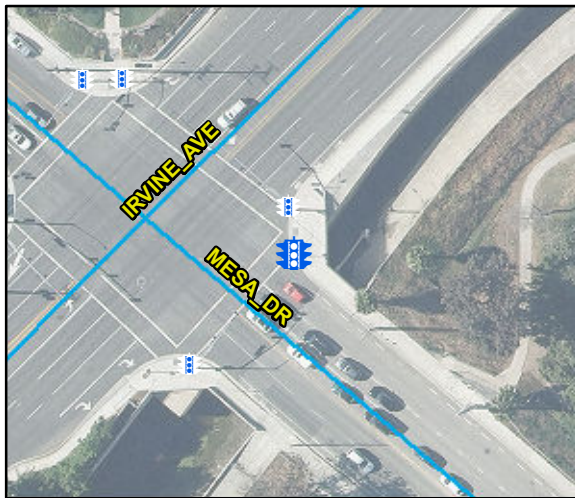
Surveyor Notes: Button 2 for Bike Lane

Possible Solutions: Replace Signal Push Button With APS Button. Remove and Replace Clear Space.

OC Std/PROW: R404.2, R404.3, R403.4, MUTCD 4e.08

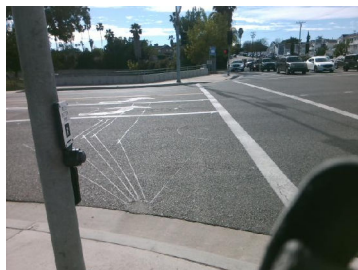
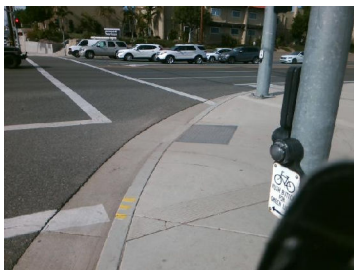
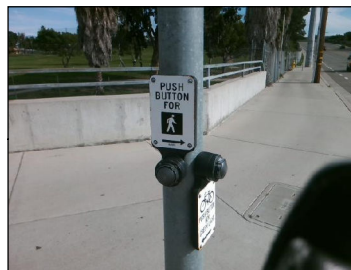
| Compliance | Description | Data | Compliance | Description | Data |
|---|---|---|---|---|---|
| No | B 1 Clear Floor Space Slope (%) | 2.9 | N/A | B 2 Clear Floor Space Slope (%) | 2.5 |
| No | B 1 Clear Floor Space XSlope (%) | 2.4 | N/A | B 2 Clear Floor Space XSlope (%) | 0.7 |
| No | B 1 Pressure (#) | 7 | N/A | B 2 Pressure (#) | 7 |

| No | B 1 Pilot Light? | No | N/A | B 2 Pilot Light? | Yes |
